Machine Status Report

Customer's Data		Machine's Data	
Company	AM Fresh Food & Drink (UK) Limited	Machine nr.	M0073/2
Address	WN8 9TQ	Date Start Up	
City	Skelmersdale	Model	H135
Country	UK		
Contact	Steven Fisher	Downtime

Hiperbaric Service's Data		Start	End
Service call nr.	7937	Dates	28/09/2023 01/10/2023
OF nr.	34835	Cycles	117350 117350

Machine status check before decommissioning

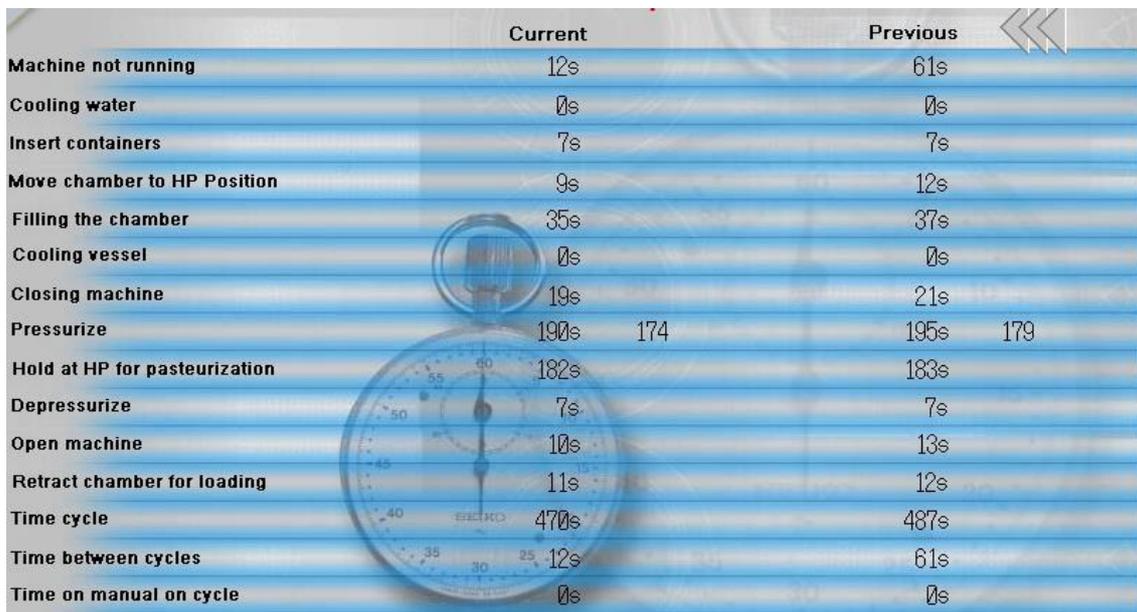
1. Stage times at 6000 bar

The stage times are within normal values for a machine that has run over 100k cycles.

Current	Previous
Machine not running	12s	61s
Cooling water	0s	0s
Insert containers	7s	7s
Move chamber to HP Position	9s	12s
Filling the chamber	35s	37s
Cooling vessel	0s	0s
Closing machine	19s	21s
Pressurize	190s 174	195s 179
Hold at HP for pasteurization	182s	183s
Depressurize	7s	7s
Open machine	10s	13s
Retract chamber for loading	11s	12s
Time cycle	470s	487s
Time between cycles	12s	61s
Time on manual on cycle	0s	0s

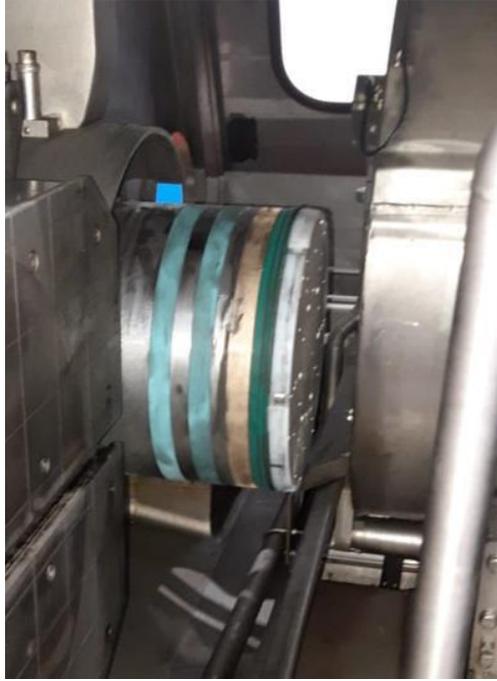
2. Side 1 plug

The general aspect of the plugs is good. No external cracks are detected on the rings. Seals are in good conditions. No leak is detected during any stage of the cycle. The slydrings are replaced in S1 plug as the old parts were not in perfect conditions.

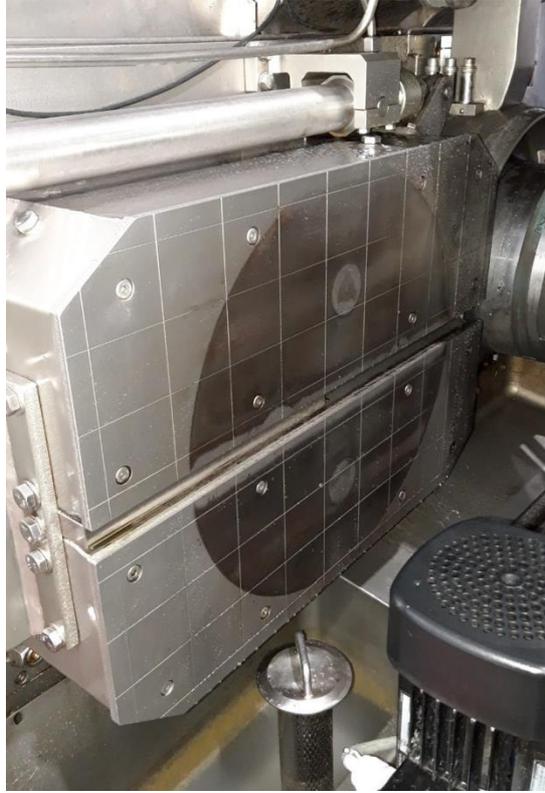
4. Side 1 wedge

Wedges state is good. No cracks on the wedge skin are detected.

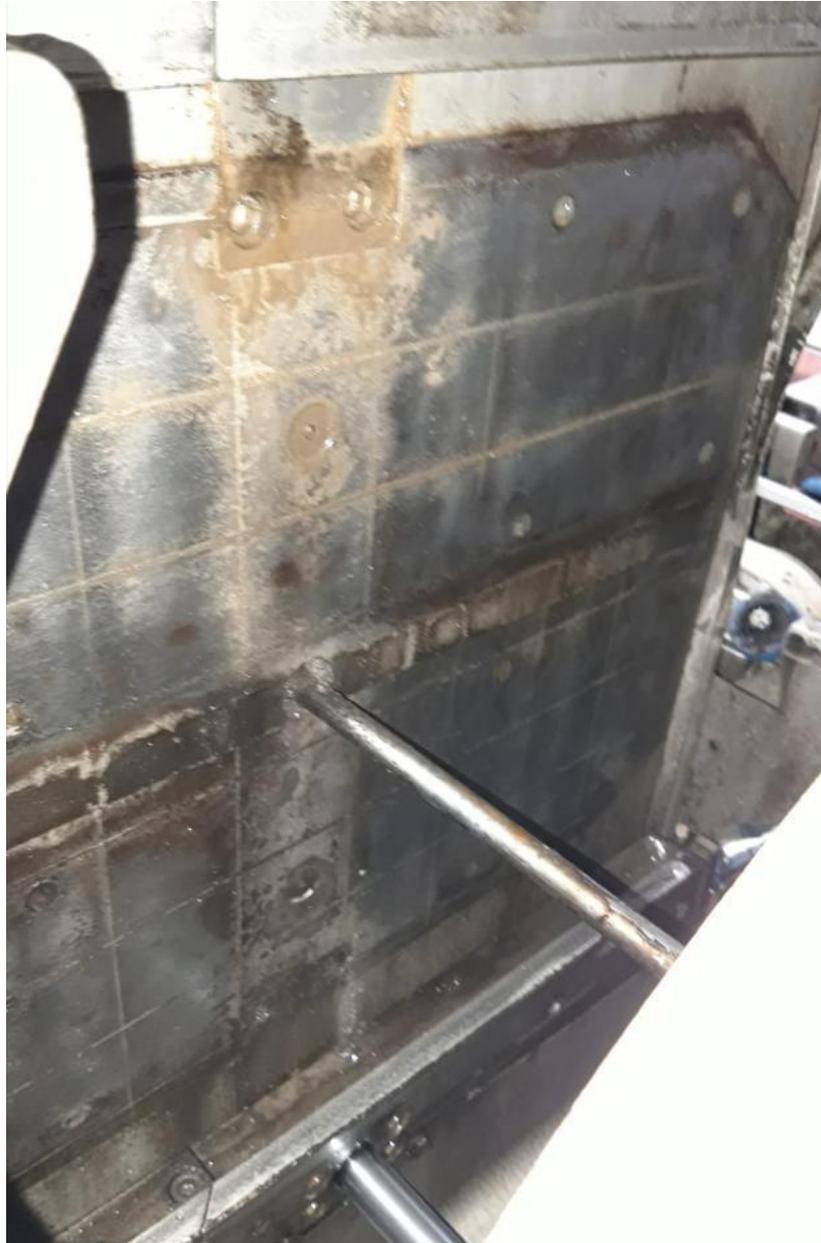
6. Side 1 H-plate

These parts do not show any crack or bending, so there is no need for replacement in the short term.

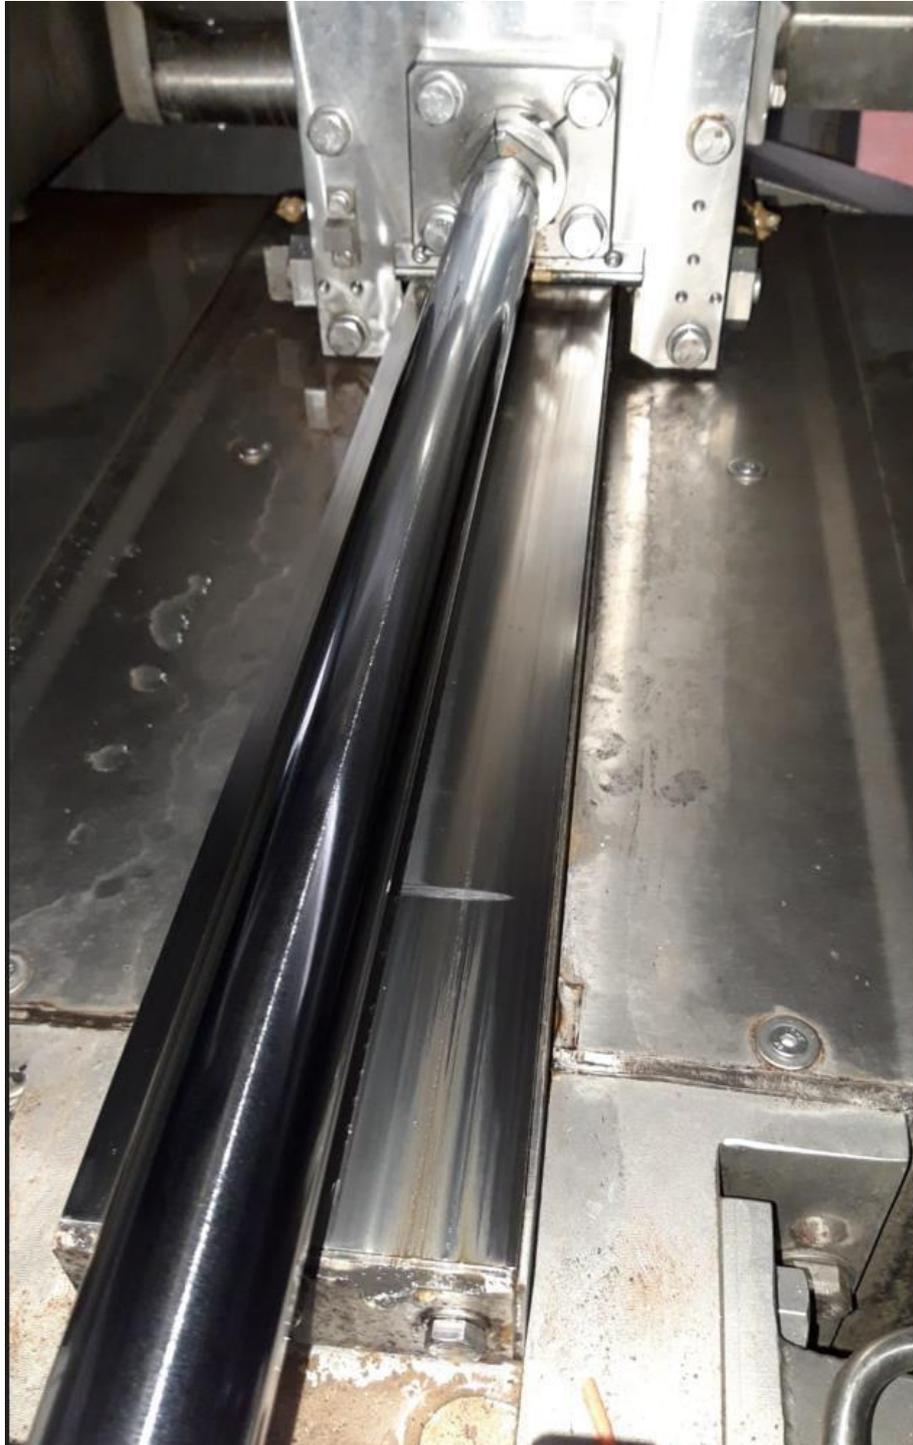
8. Side 1 rolling guide

The guides show no scratch or deep marks, indicating a good status of the wheels and bearings.

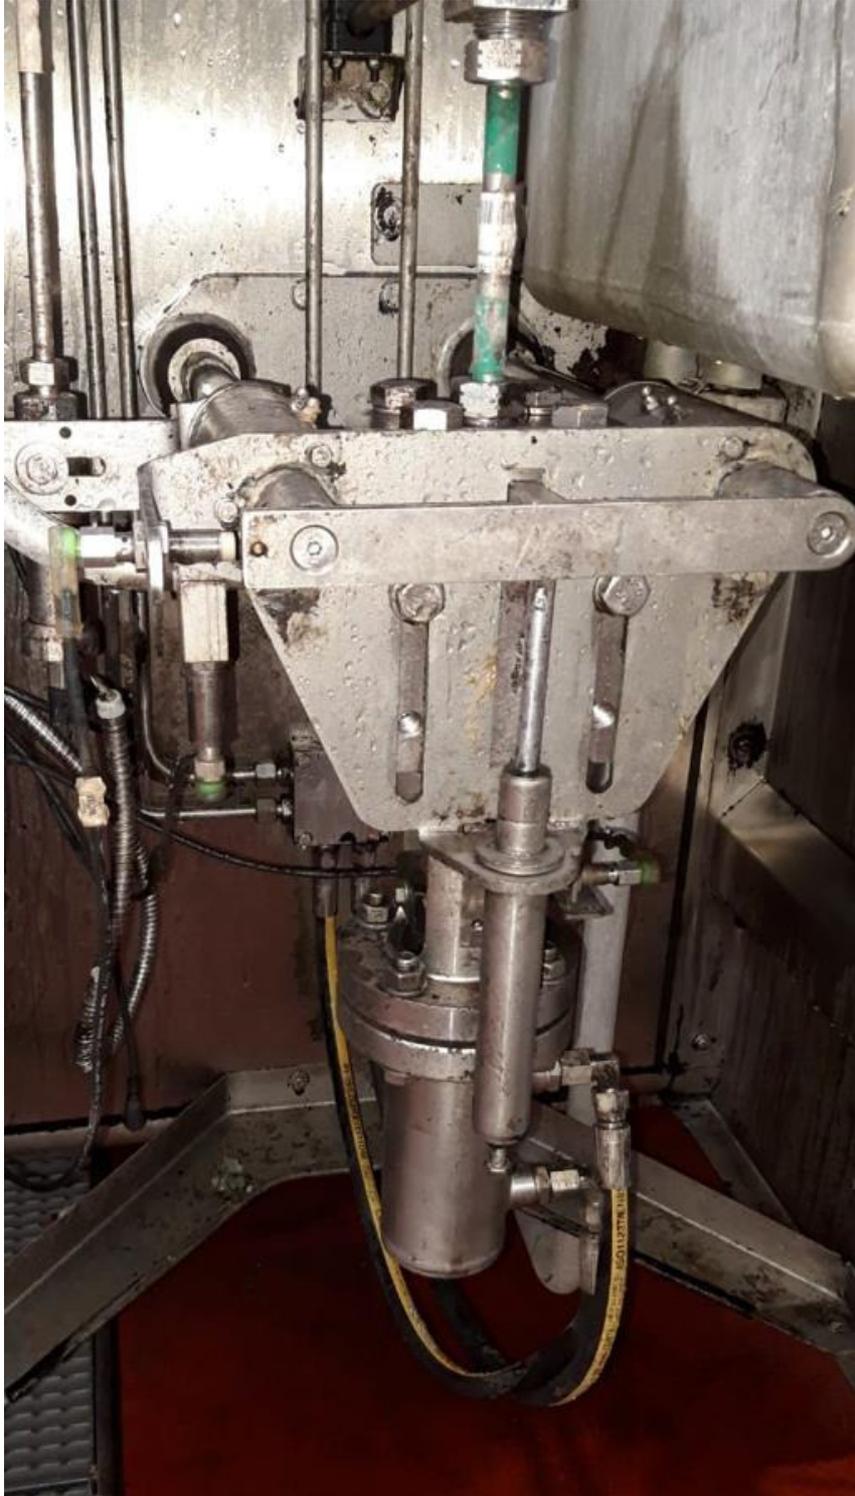
10. Side 1 discharge valve

No high-pressure leak is detected on these components.

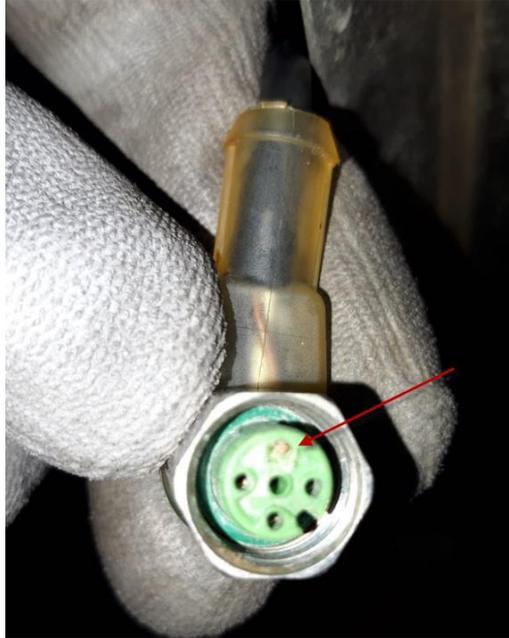
- A discharge valve temperature sensor cable has one pin inserted on it, and it need to be replaced as this pin cannot be extracted.

12. Broken pin in the connector

The missing material can be sent, so it can be replaced when the machine is started up again.

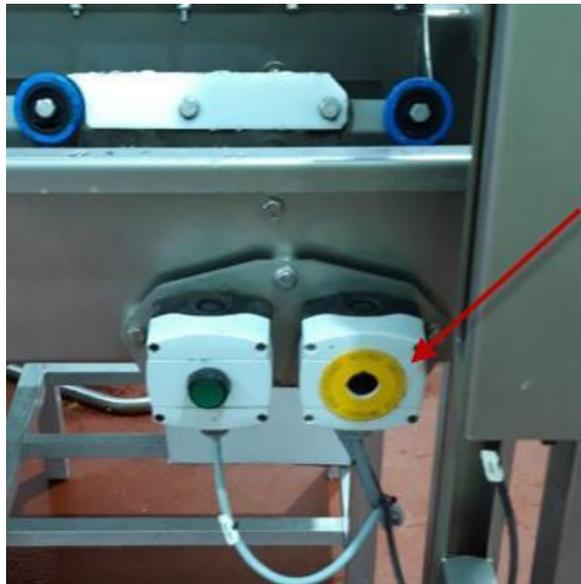
- An emergency stop button is missing in the output conveyor.

13. Missing button

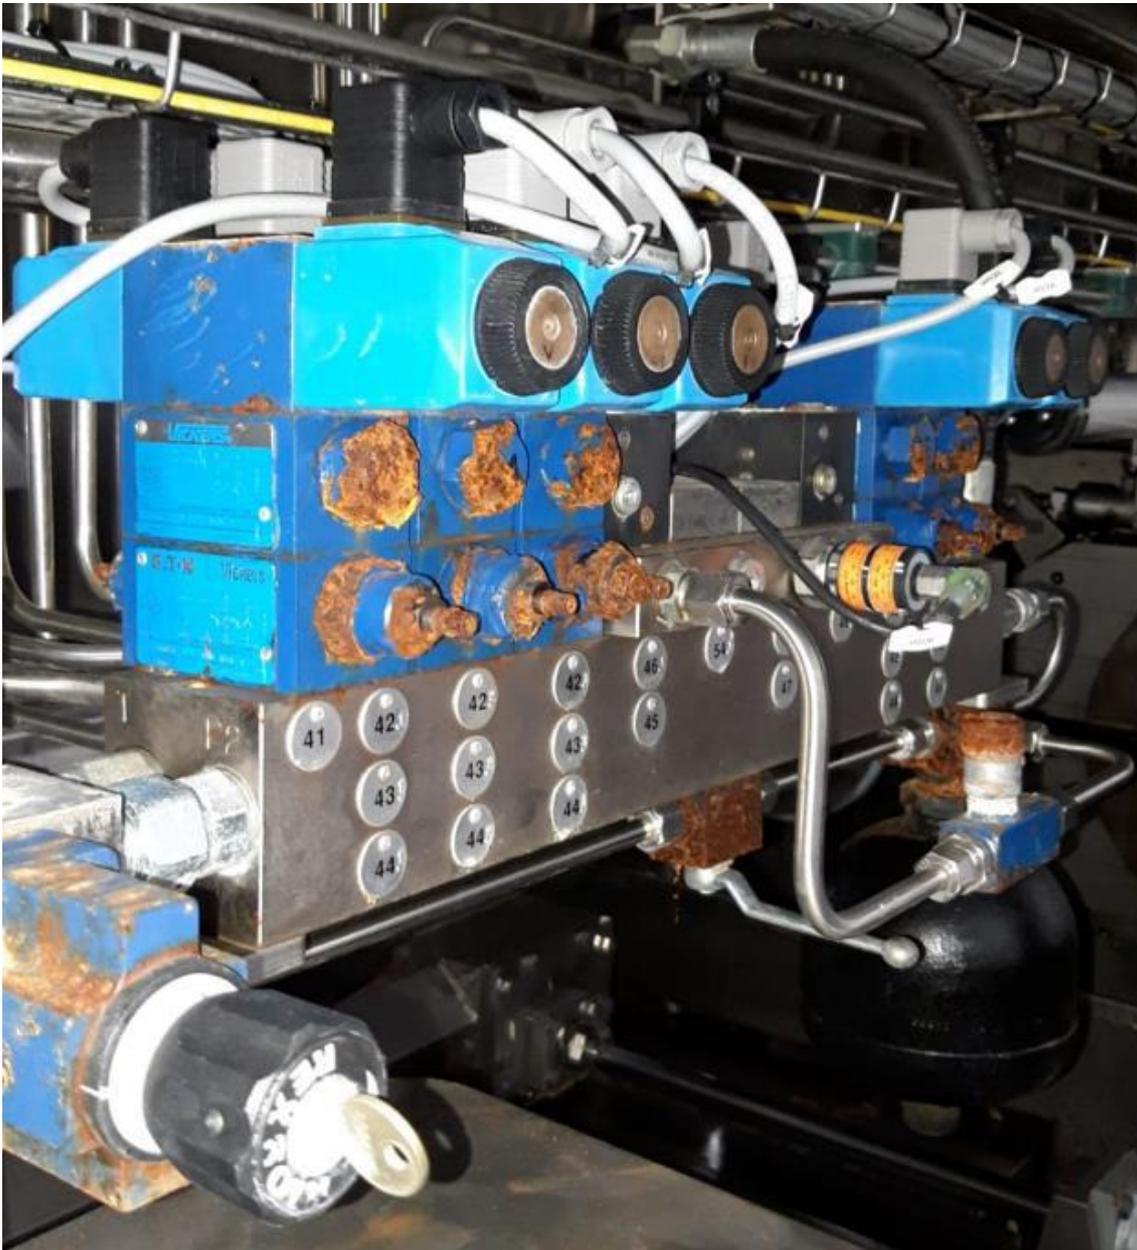
14. Hydraulic block

Some valves in the hydraulic block show external corrosion. However, they work properly.

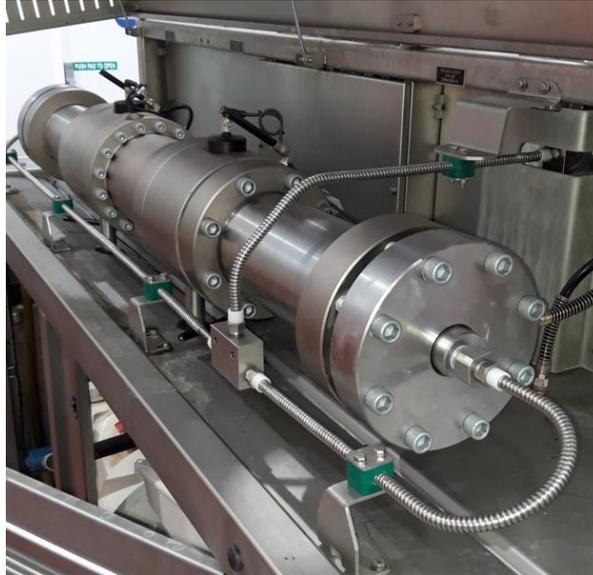
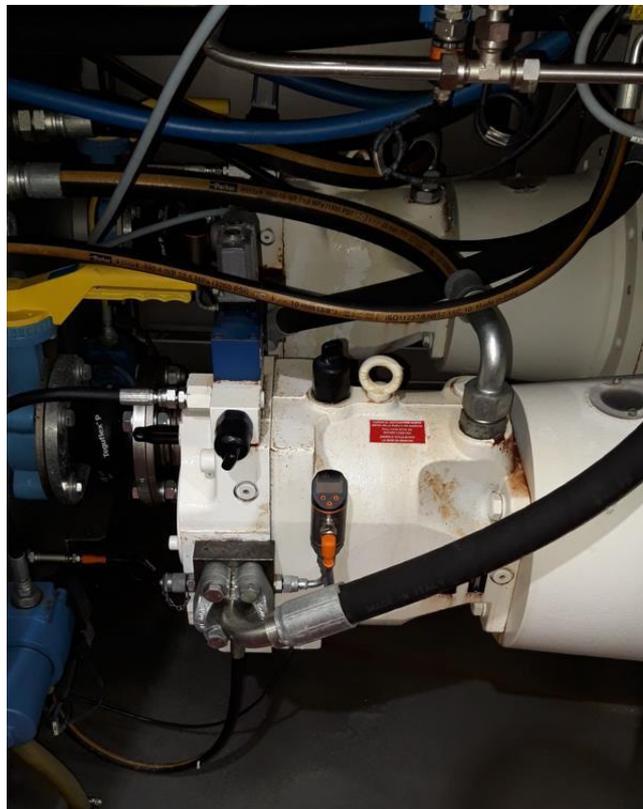
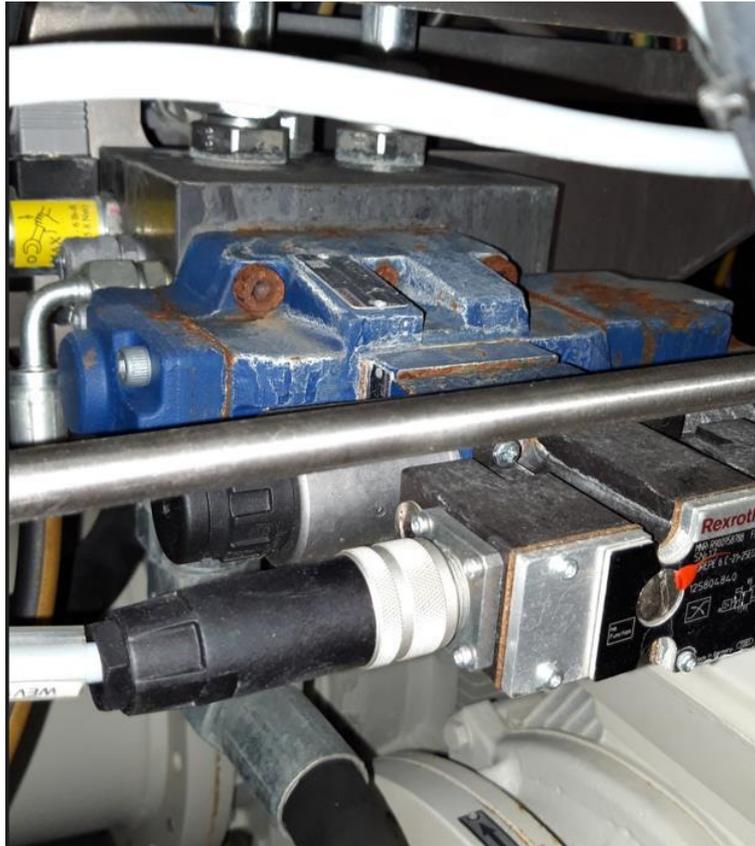
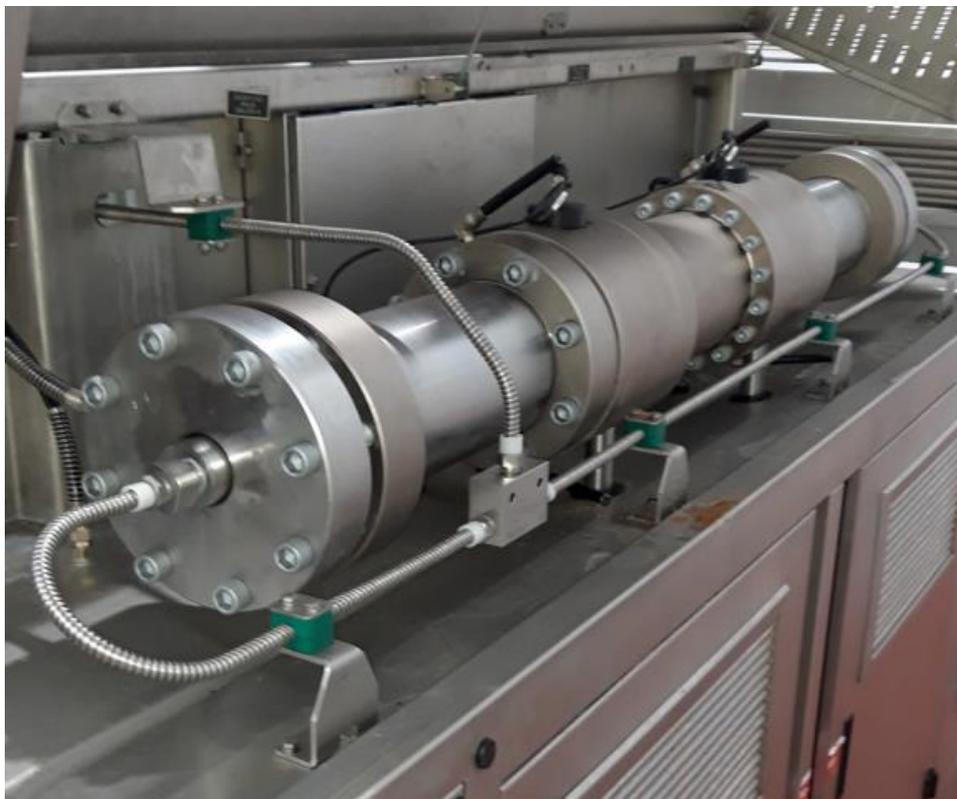
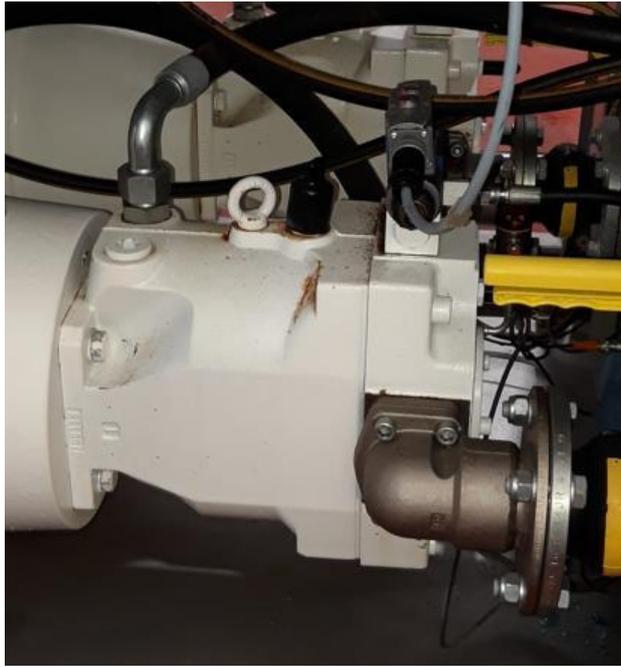
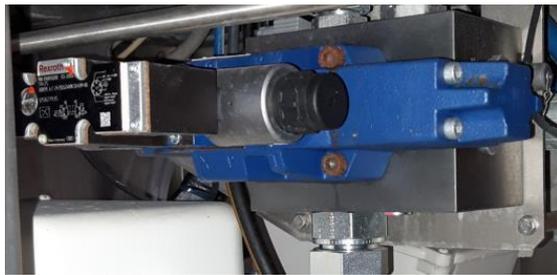
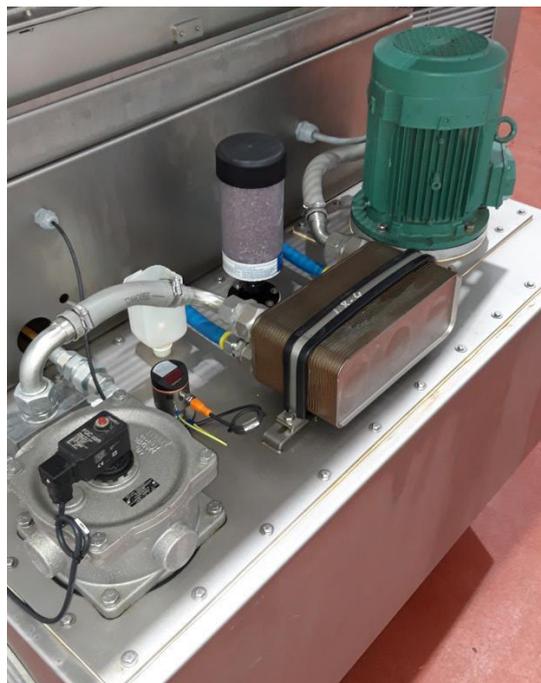
After a high-pressure seal replacement, no water or oil leak is detected. No malfunction is detected in the intensifier. The external part of some hydraulic component present some rust, but these parts are working properly.
